UNITED STATES ENVIRONMENTAL PROTECTION AGENCY

Re: Notice of Violation  
Compliance Evaluation Inspection  
ILD 005 215 116

Attachment 1  
Pamarco-RCRA CEI  
EPA ID Number: ILD 005 215 116  
September 10, 2018

Site Diagram 1: February 13, 2019 • Pamarco Global Graphics (0890100008) • Kane County

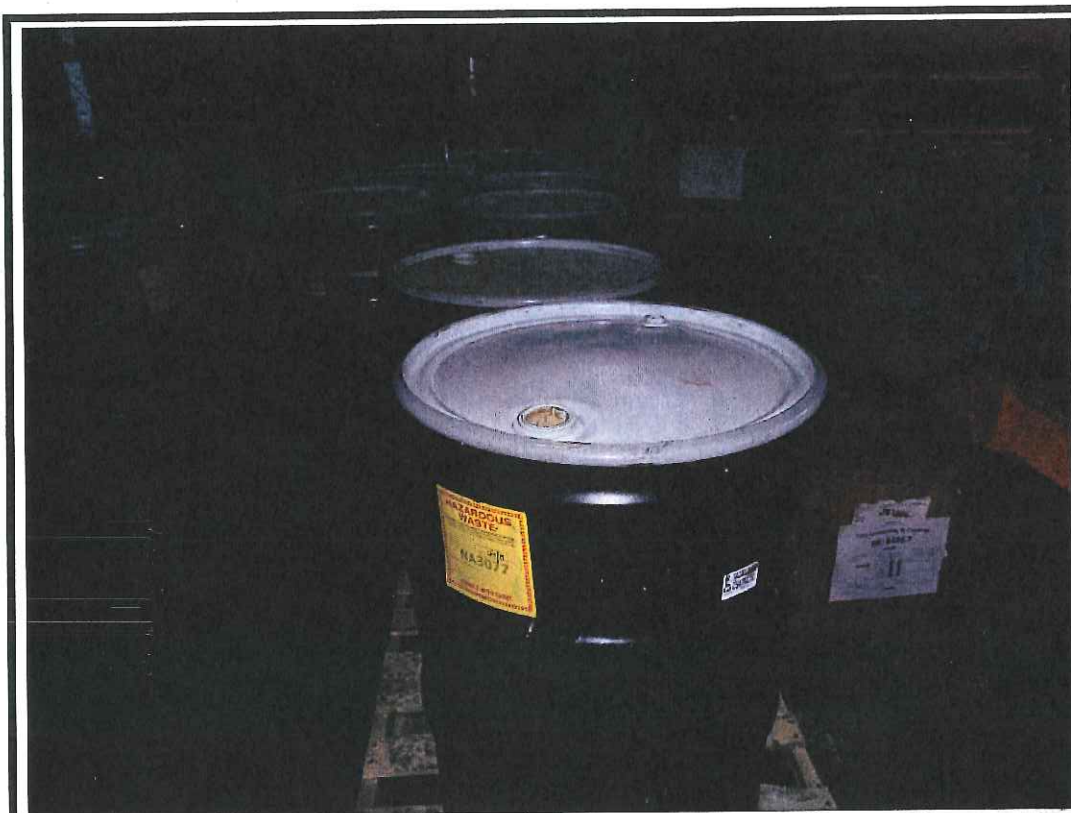
Photo ID: 1  
Photo Date: 2/13/2019  
Photo Time: 11:04:57  
Direction: West  
Taken By: Tina Kovaszny

Hazardous waste storage area.

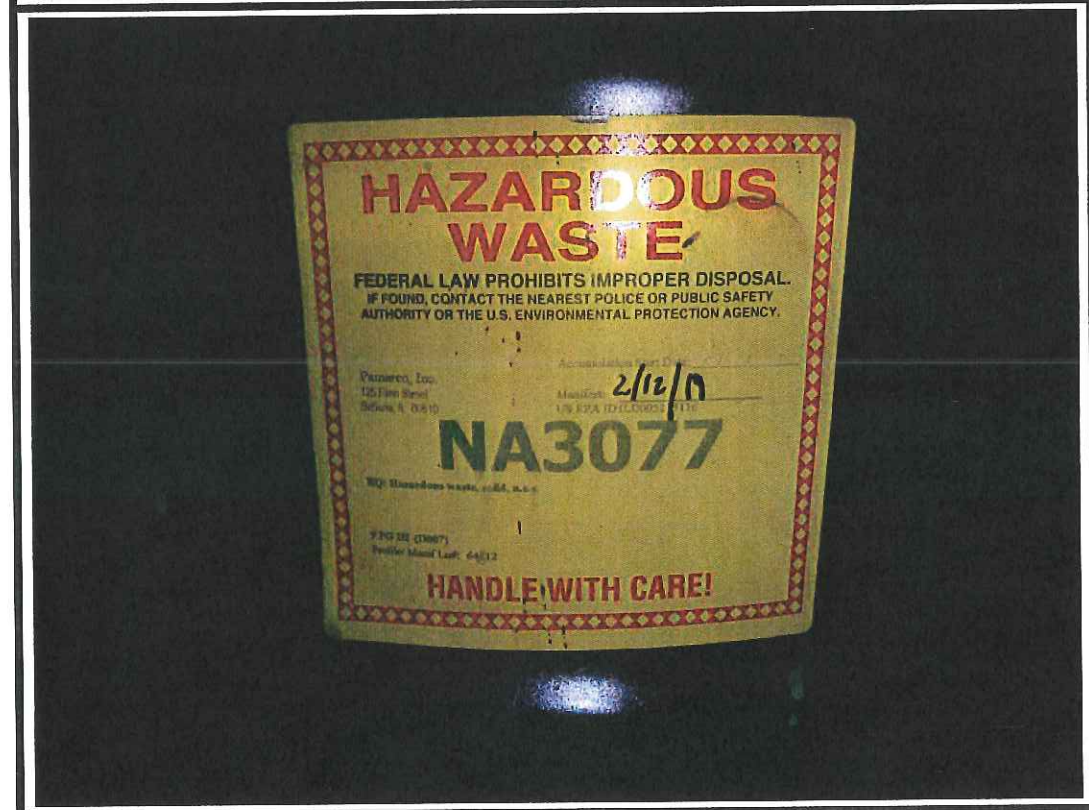
Photo ID: 2  
Photo Date: 2/13/2019  
Photo Time: 11:05:19  
Direction: North  
Taken By: Tina Kovaszny

At the time of the Illinois EPA Inspection, Pamarco was accumulating hazardous waste in one container without the accumulation start date. Pamarco marked the container with an accumulation start date during the inspection.

Hazardous waste drum had no date - corrected at the time of the inspection.

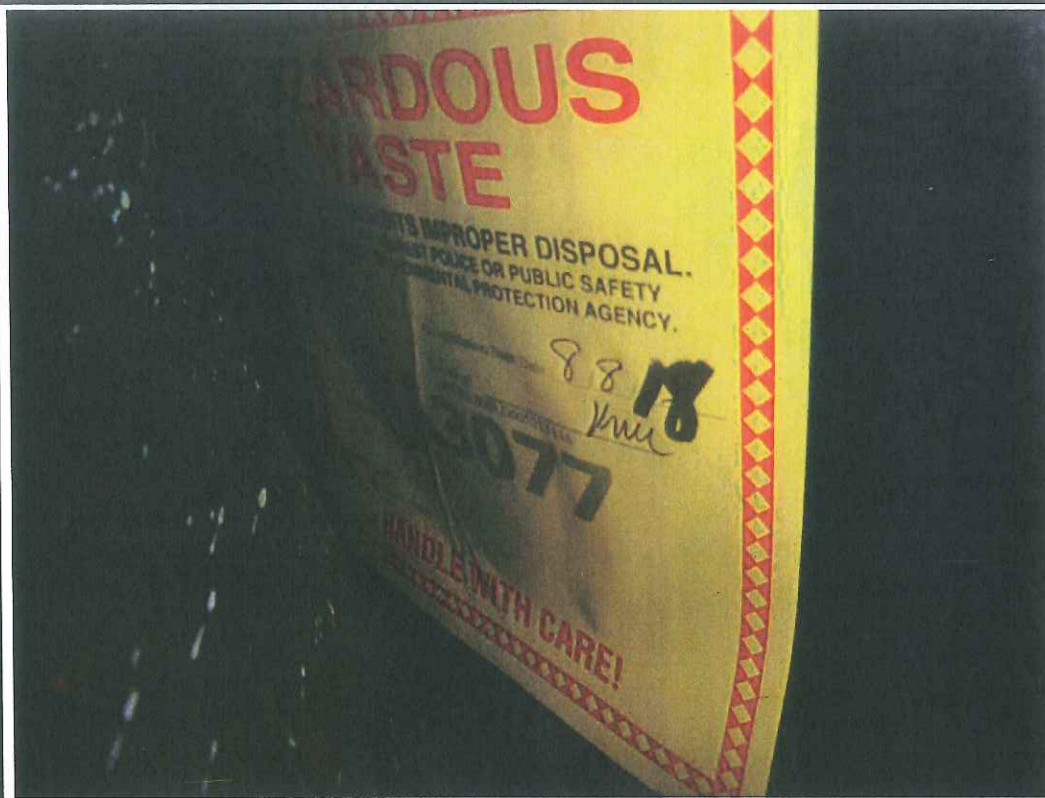
Photo ID: 7  
Photo Date: 2/13/2019  
Photo Time: 11:06:03  
Direction: Southwest  
Taken By: Tina Kovasznay

At the time of the EPA and Illinois EPA Inspections, Pamarco was accumulating hazardous waste in several containers and two tanks for more than 90 days.

Hazardous waste drum stored on-site for greater than 90 days. Date changed from 2015 to 2018.

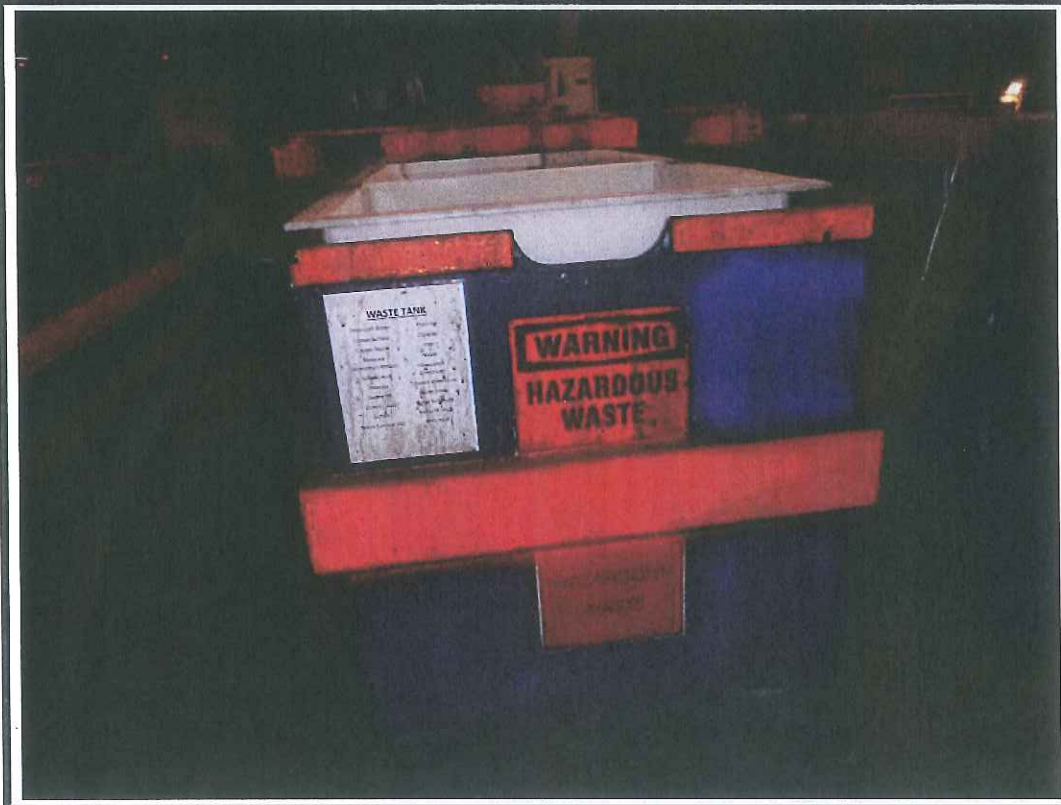
Photo ID: 8  
Photo Date: 2/13/2019  
Photo Time: 11:25:15  
Direction: East  
Taken By: Tina Kovasznay

Hazard waste accumulation tank.

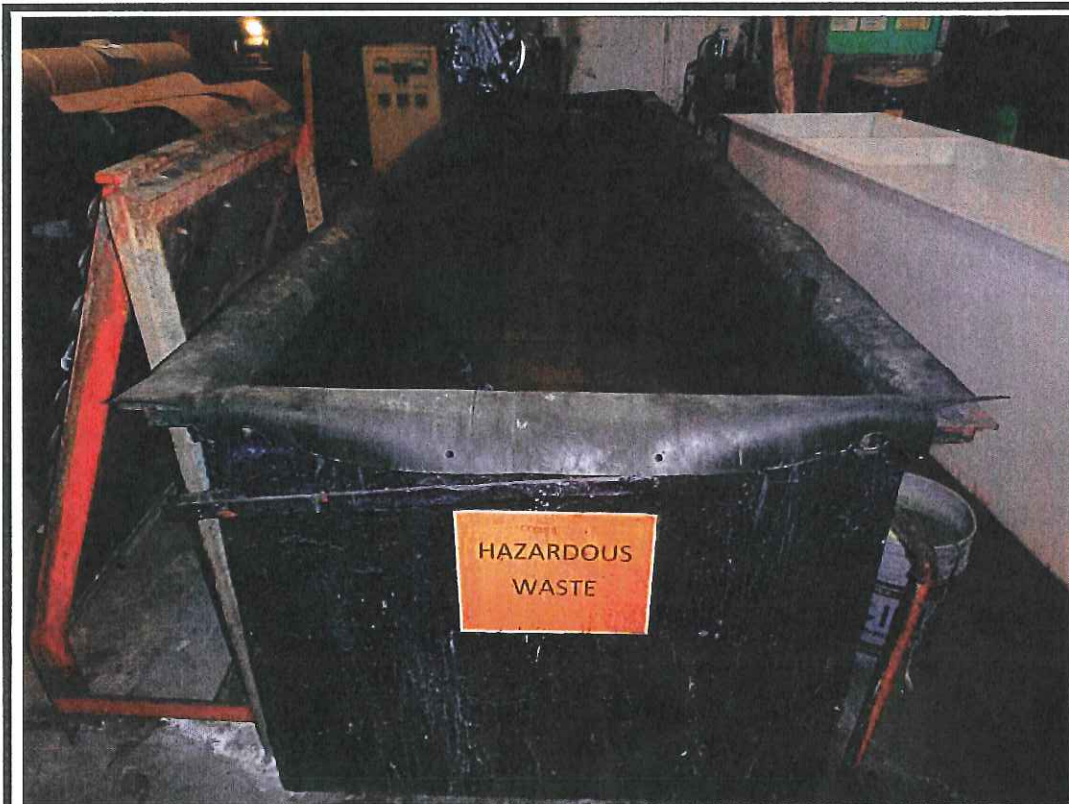
Photo ID: 9  
Photo Date: 2/13/2019  
Photo Time: 11:25:57  
Direction: East  
Taken By: Tina Kovasznay

Hazardous waste storage tank  
with no secondary  
containment.
